NBSIR 82-2465

Investigation of the Kansas City Hyatt Regency Walkways Collapse

February 1982

**INVESTIGATION OF THE KANSAS CITY
HYATT REGENCY WALKWAYS COLLAPSE**

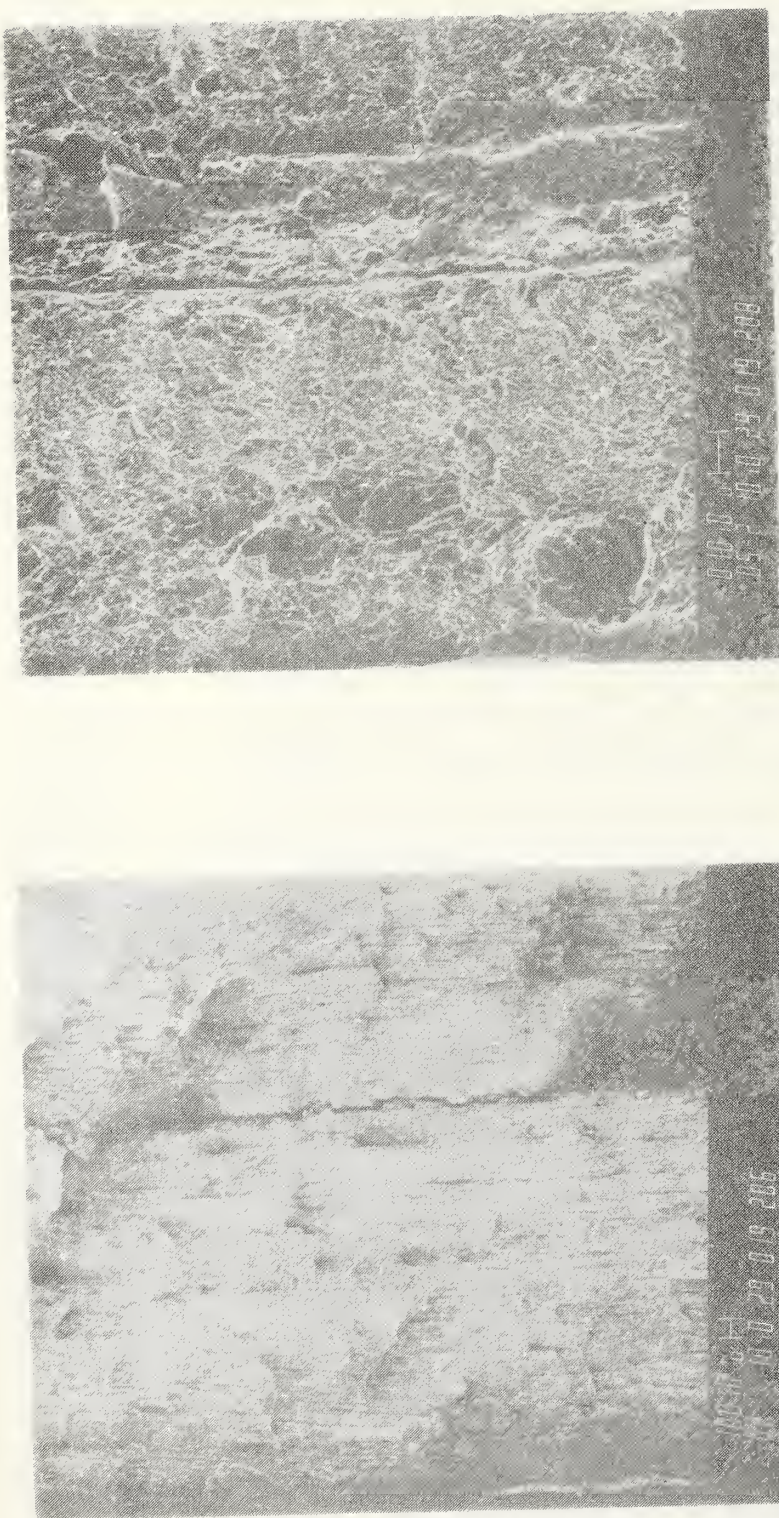
Figure 8.14 Fractographic appearance of NBS washer No. 3 broken at NBS. Low magnification view (a) shows elongated MnS inclusions. Higher magnification view of center portion (b) shows essentially ductile rupture. Magnification (a) X25, (b) X550.

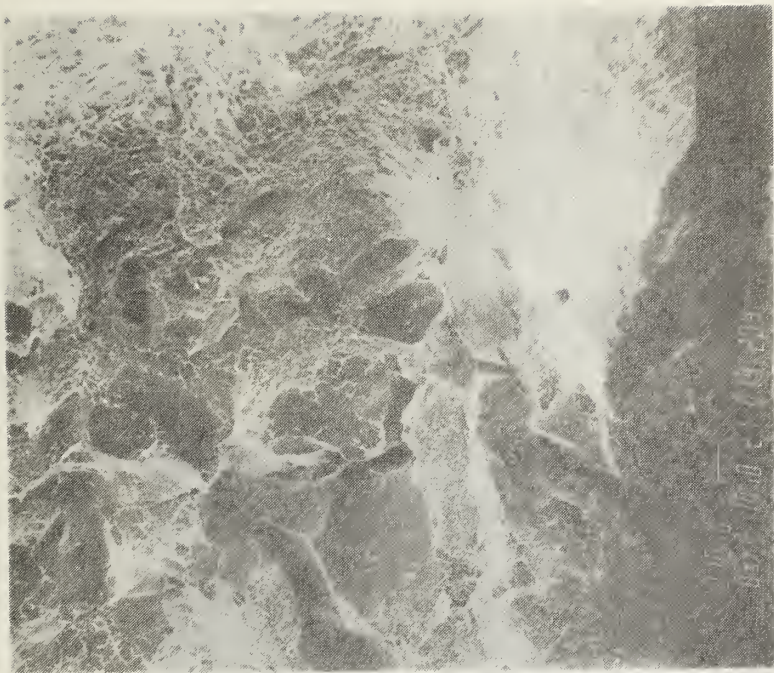
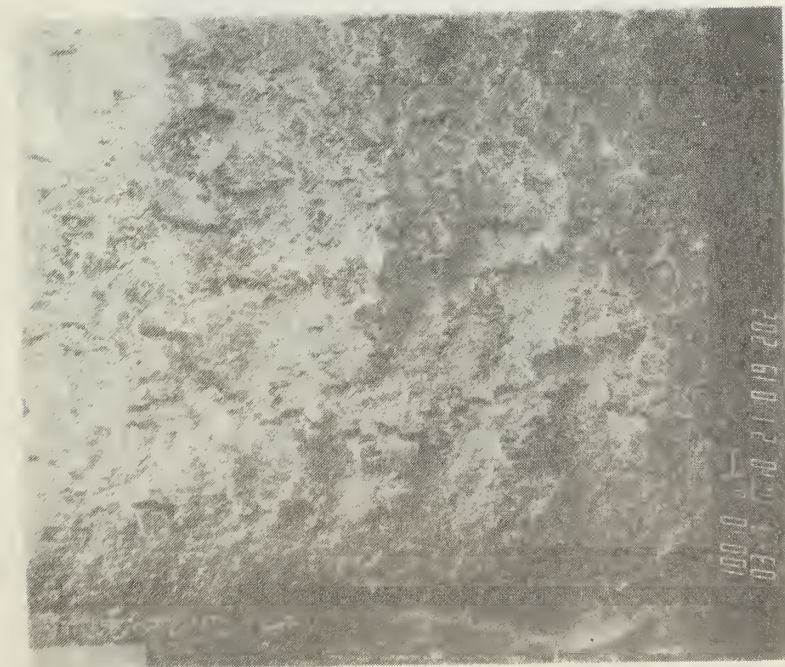
Figure 8.15 Fractographic appearance of NBS washer No. 2 broken at NBS. Low magnification view (a) shows no prominent MnS inclusions. Higher magnification view of center portion (b) shows 15-20 percent brittle intergranular fracture along with ductile rupture. Magnification (a) X35, (b) X550.

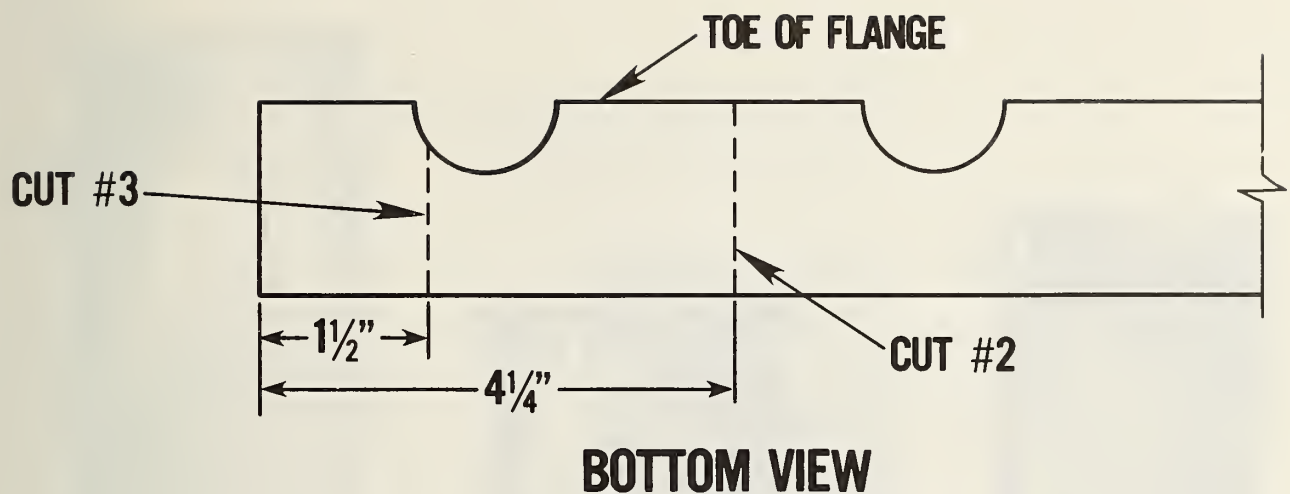
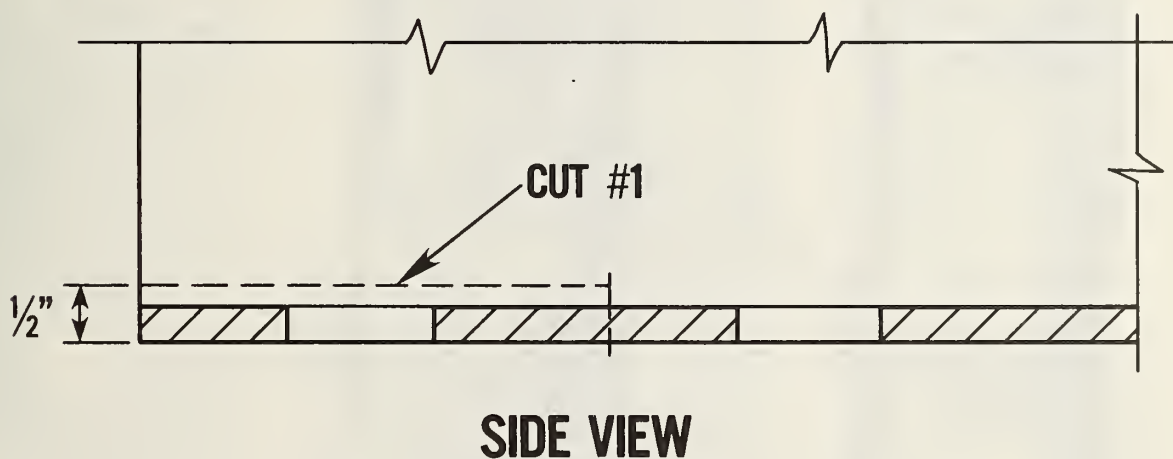
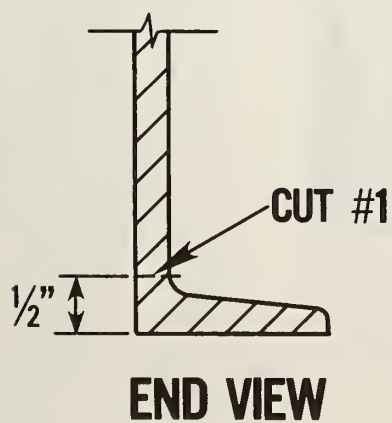
Figure 8.17 Schematic of cuts performed to remove one half of the lower fracture surfaces for fractographic analysis.

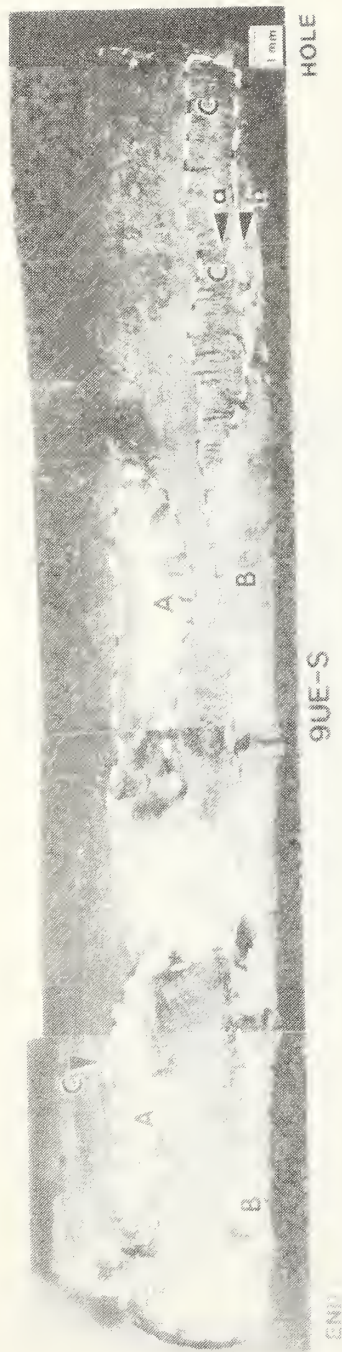
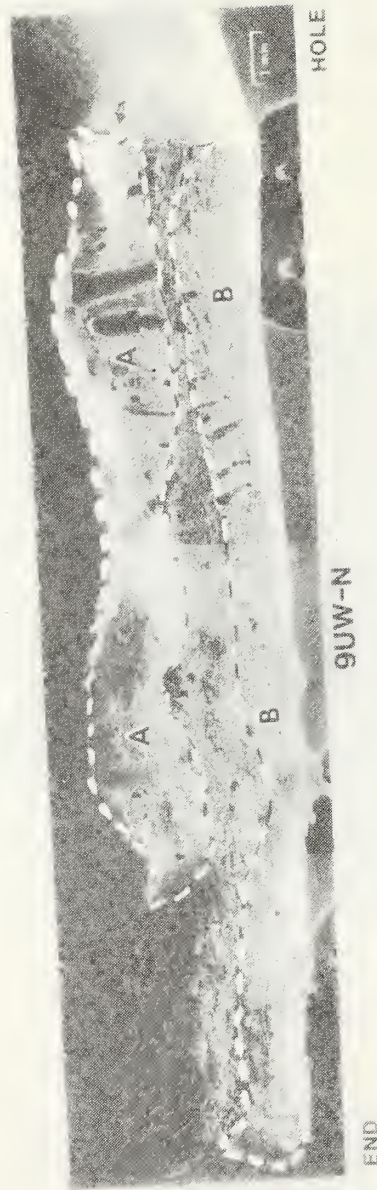
Different textures in the fracture topography provided evidence that cracks had existed in the weld roots in the regions between the hanger rod holes and in the regions between the outer hanger rod holes and beam ends prior to gross weld failure at the time of collapse. Figures 8.5 (a-c) illustrate the appearance of several such regions in the exterior longitudinal welds at locations 9UW, 9UE and 8UW.

Figure 8.18 One half of box beam lower fracture surface between beam end and outer hanger rod hole.

(A) fracture area of the interior tack weld, (B) exterior longitudinal weld, (C) preexisting crack regions. This designation also is applicable to figures 8.19, 8.20, and 8.21. (a) and (b) noted by arrows on 9UE, indicate locations of figures 8.22 (a) and (b), respectively.

(a) location 9UE - S (optical, magnification X4.5)

(b) location 9UW - N (SEM, magnification X6.5)

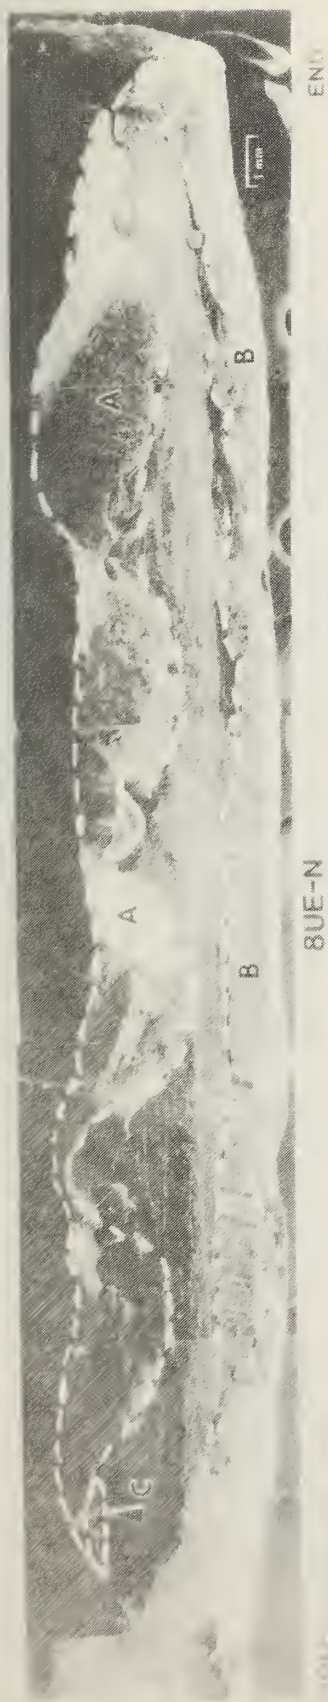
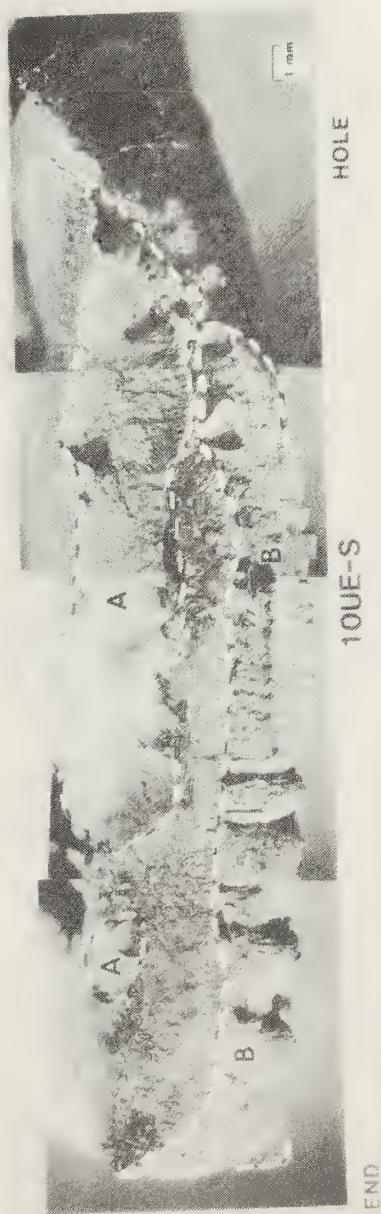
Figure 8.19 One half of box beam lower fracture surface between beam end and outer hanger rod hole.

(a) location 8UE - N (SEM, magnification X6.5)

(b) location 10UE - S (optical, magnification X4.5)

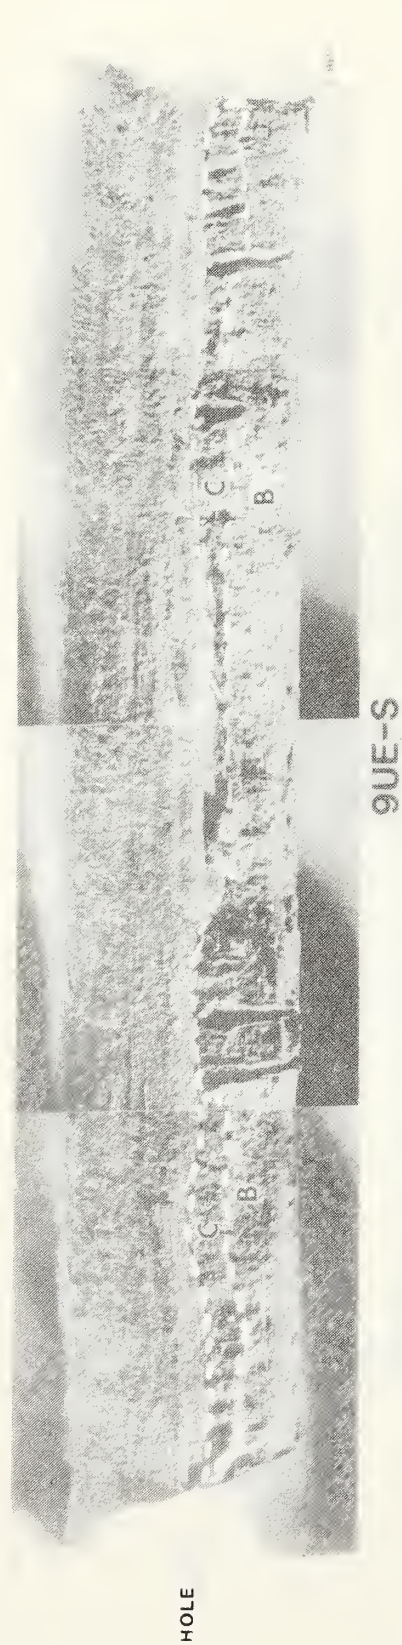
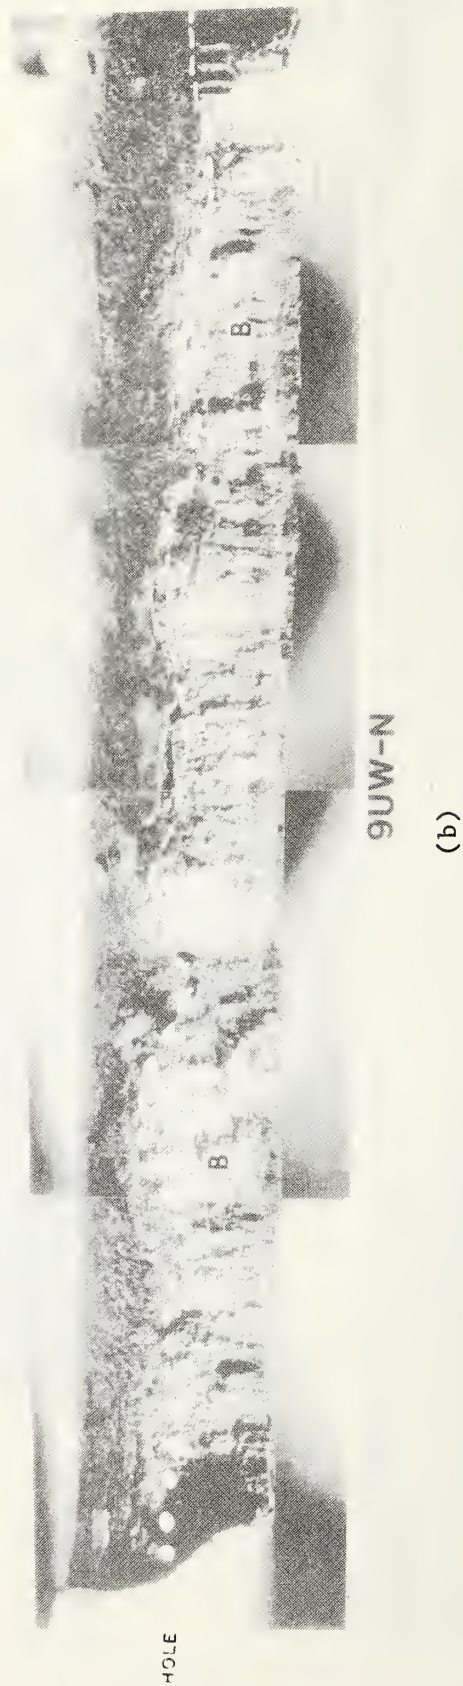
Figure 8.20 One half of box beam lower fracture surface between outer and inner hanger rod holes.

(a) location 9UE - S (optical, magnification X5.5)

(b) location 9UW - N (optical, magnification X5.5)

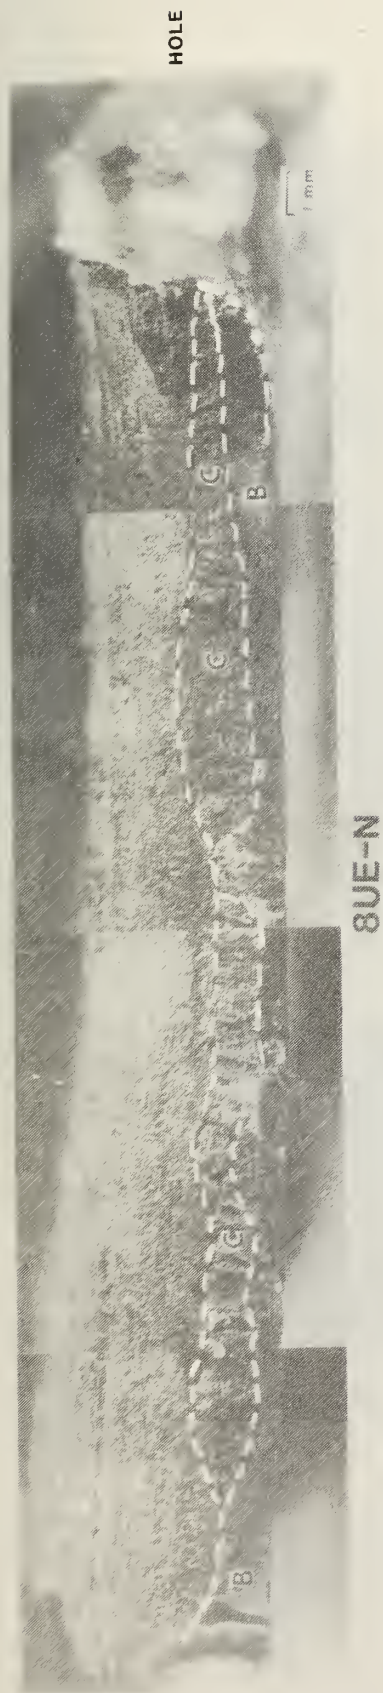
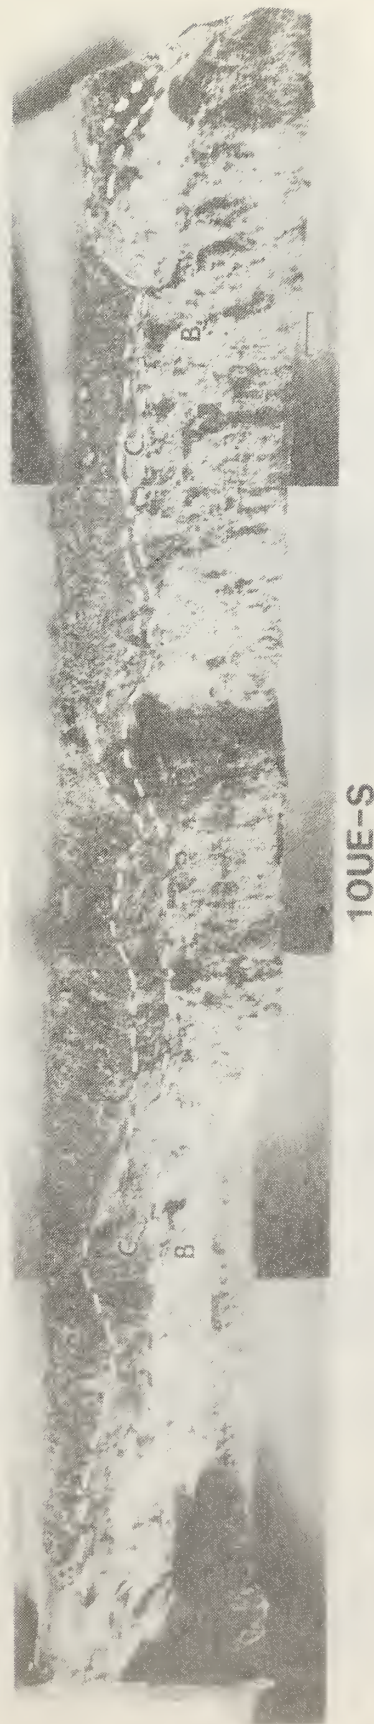
Figure 8.21 One half of box beam lower fracture surface between outer and inner hanger rod holes.

(a) location 8UE - N (optical, magnification X5.5)

(b) location 10UE - S (optical, magnification X5.5)

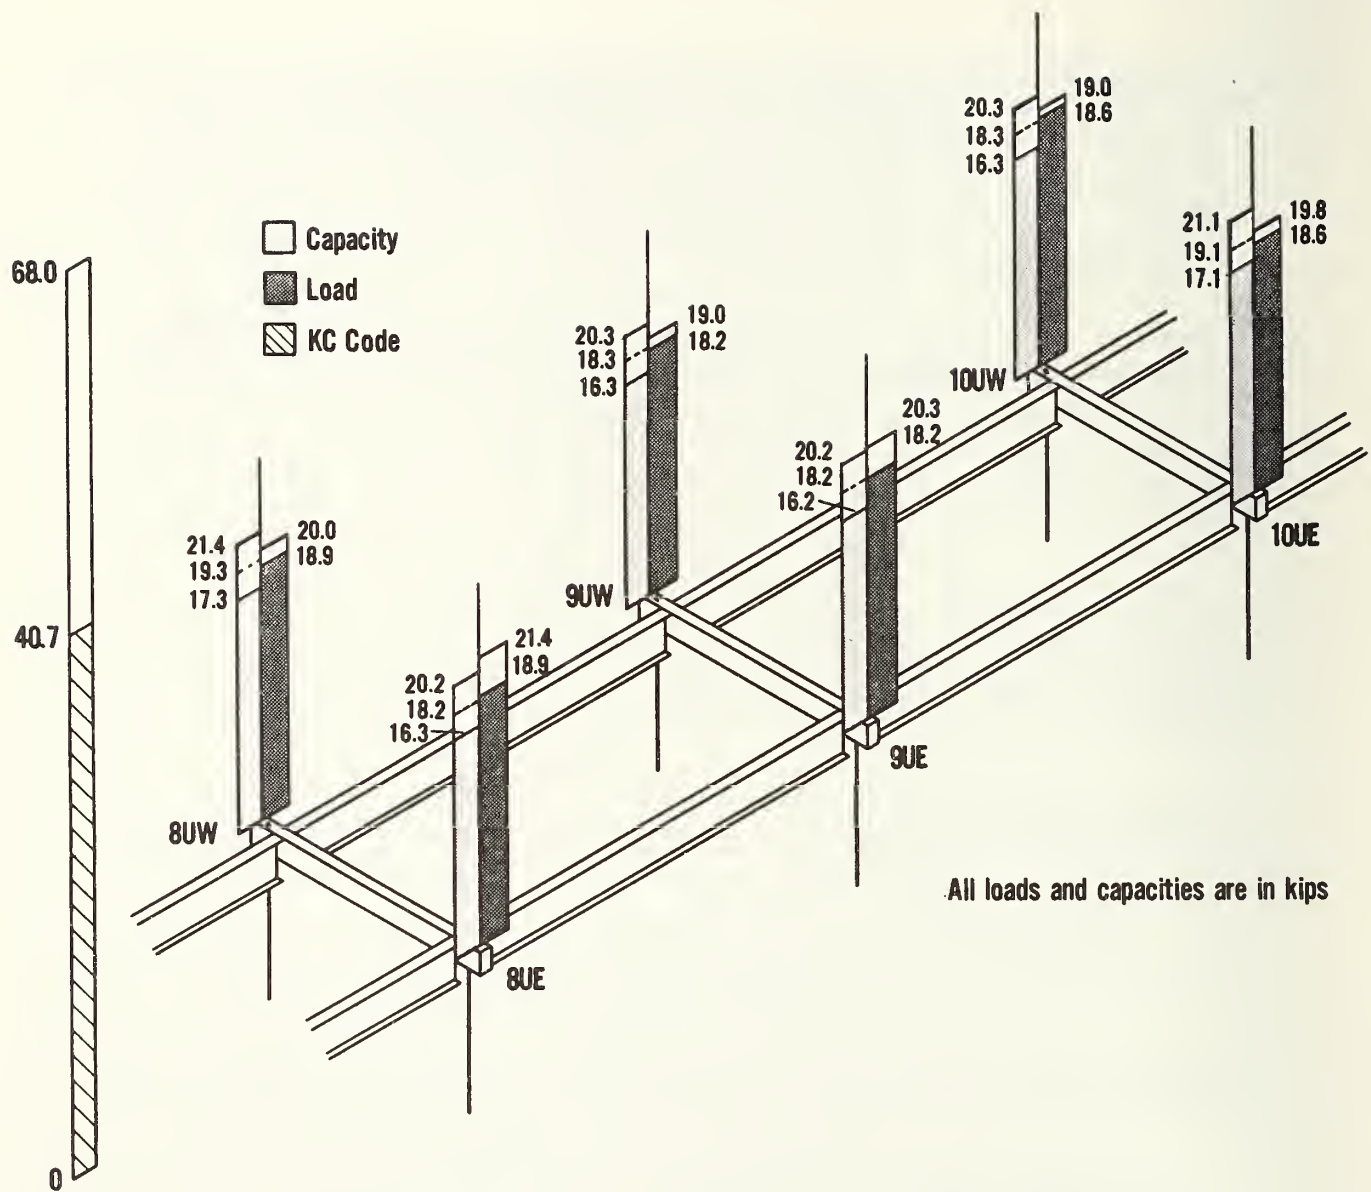
It is important to point out that the load capacities described in figure 10.1 are ultimate values. As noted in section 9.3.3, the design load (estimated nominal dead load plus code-specified design live load) for a fourth floor to ceiling hanger rod is 40.7 kips (181 kN). This is the load that should be used in a working stress approach to design in which the nominal strengths of materials are reduced by an appropriate factor of safety.

the AISC Specification is the basis for the steel design provisions of the Kansas City Building Code, this same ultimate load capacity would be expected of a connection designed under the Kansas City Building Code. The hanger rod load to be applied in working stress design under the Kansas City Building Code and the expected ultimate load capacity are shown in the bar diagram on the left in figure 10.1.

Figure 10.1 Comparison of fourth floor walkway box beam-hanger rod connection capacities with loads believed to have been acting at time of collapse.

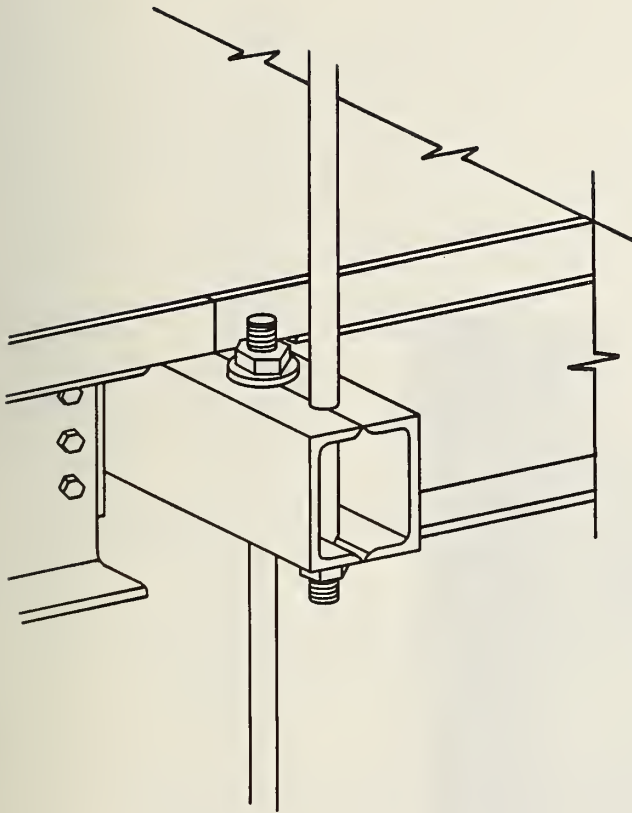
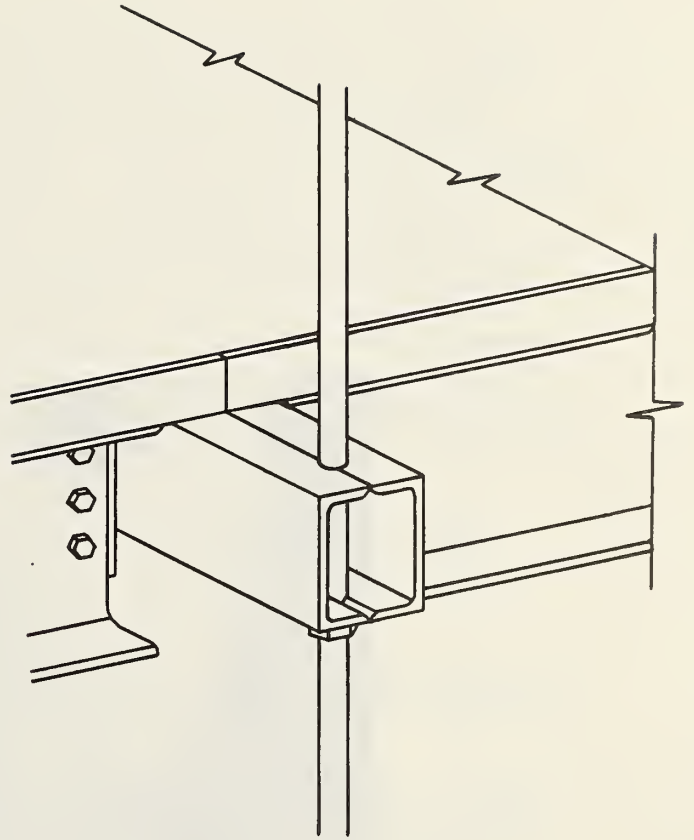
As has been described in chapter 3, the hanger rod configuration actually used consisted of two hanger rods: the fourth floor to ceiling hanger rod segment as originally detailed and the second to fourth floor segment offset 4 in (102 mm) inward along the axis of the box beam (see figure 10.2). The washer and nut arrangement called for in the original connection detail as shown on Dwg. S405.1 was retained in the actual construction. With this modification the design load to be transferred by each second floor box beam-hanger rod connection was unchanged, as were the loads in the upper and lower hanger rod segments. However, the load to be transferred from the fourth floor box beam to the upper hanger rod under this arrangement was essentially doubled, thus compounding an already critical condition. The design load for the fourth floor box beam-hanger rod connection would be 40.7 kips (181 kN) for this configuration.

10. Had the change in hanger rod arrangement not been made, the third floor walkway would have been the most critical of the three, the ultimate capacity of the connections being approximately 53 percent of that which would be expected of a connection designed in accordance with the AISC Specification.

Figure 10.2 Comparison of interrupted and continuous hanger rod details.

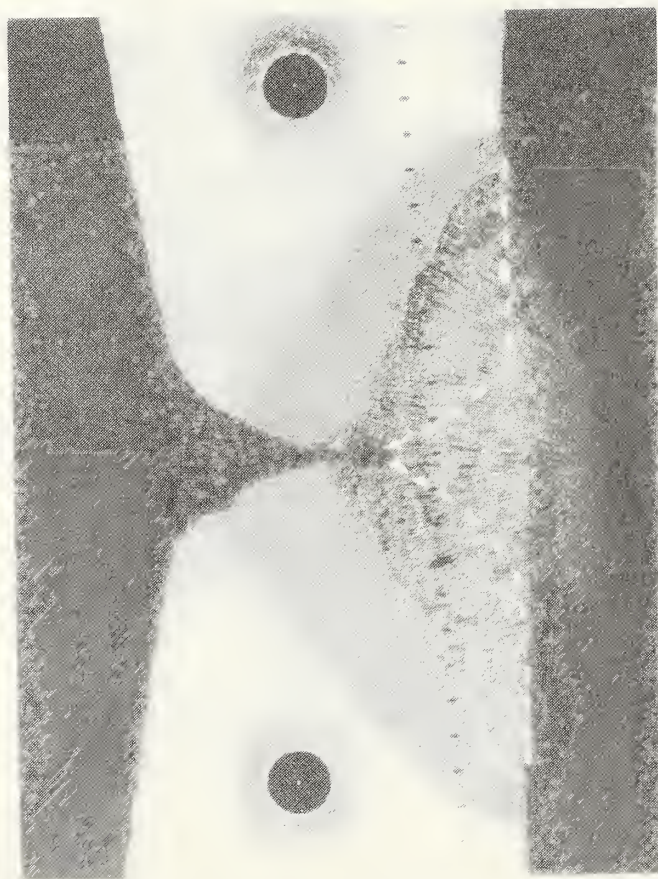
The welding symbol and field observations relevant to the box beam longitudinal welds have been discussed in sections 3.3 and 5.3.3, respectively. As noted in section 3.3, the welding symbol used on the shop drawings is interpreted to require a prequalified partial joint penetration groove weld. However, the geometry of the mating surfaces as discussed in section 5.3.3 and as illustrated in figure 10.3 does not satisfy the dimensional tolerances for a prequalified partial joint penetration groove weld as stated in section 2.10 of AWS D1.1-79; the root face is less than 3 mm (Item 2.10.2.4), and the required minimum root opening was not provided.

11. Average joint penetration for the box beam longitudinal welds was less than that required by AWS D1.1-79 for a prequalified partial joint penetration groove weld. However, it is concluded that due to the presence of tack welds the actual ultimate capacities of the box beam-hanger rod connections probably were higher than would be expected for a partial joint penetration groove weld with the prescribed minimum effective throat acting alone.
12. There is no evidence to indicate that either quality of workmanship or materials played any significant role in initiating the collapse.

Figure 10.3 Cross section through weld region of walkway box beam 8L showing the exterior longitudinal weld joint at the bottom flange. Dotted lines indicate approximate original geometry of the flange toes. X8 1/2
